Landslide25_10**The slope local stability assessment at the gazebos locations on the Volodymyrska Hirka**

The report presents the inspection of the slope section with gazebos and the assessment of its local stability, as well as the inspection of the path in Volodymyrska Hirka Park and the evaluation of its technical condition. During the visual survey and assessment of the path and the surrounding slope, numerous defects and damages were identified. According to current regulatory standards, the technical condition was classified as hazardous. On the slope, “drunken forest”-type leaning trees and extensive areas of soil erosion caused by atmospheric water were observed. A lighting pole was tilted due to uneven deformation of its foundation. The local stability of the slopes in the gazebo areas was analyzed using four engineering–geological cross-sections developed based on the survey results. The soil mass was modeled according to the Mohr–Coulomb failure criterion. The calculations indicated that in certain sections, slope failure could occur under water-saturated soil conditions, while in other sections the slopes were found to be in a state of limiting equilibrium.

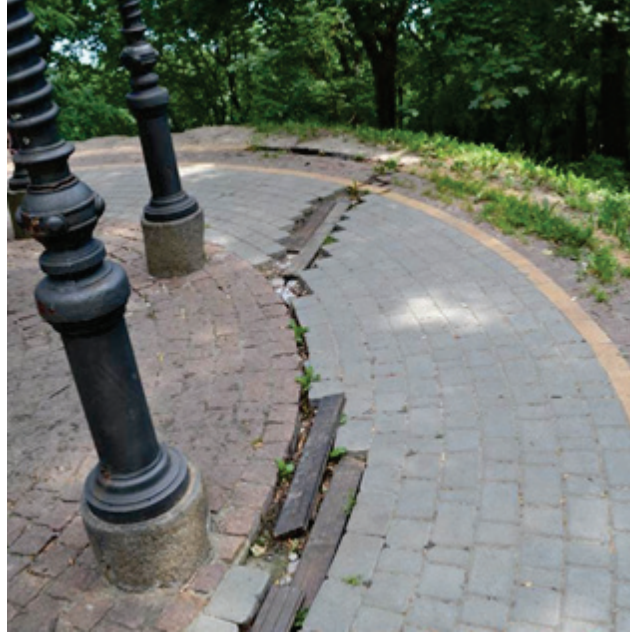
Figure 1 Cracks in the paving around the gazebo caused by the base uneven deformation; the crack opening width exceeds 50 mm.

During the visual inspection of the path and slope around it and their technical state determination, the following defects and damages were found: steps that protruded from the plane and were curved; steps having through-going cracks with an opening width of up to 15 mm; steps that were not fixed and had various inclination angles; an area where some steps were completely absent; areas with destroyed steps; the through-going cracks with an opening width of up to 50 mm along the entire height of the walls along the stairs; the drainage trays that were destroyed, leaky, littered with garbage and wall decoration slabs; areas with destroyed paving, tilted curb stones and destroyed causeway were everywhere on the stairs. The totality of the above-mentioned damages was caused by the unfavorable operating conditions, significant period of the stairs use without repair and soil base uneven deformation due to soaking. According to the current regulatory documents, the technical state was considered an emergency. During the slopes inspection along the stairs, the following was recorded: on the slopes there were "drunken forest" inclined trees; the lighting pole was inclined due to the base uneven deformation; on the slopes there were the widespread areas with the soil eroded by atmospheric waters as the water erosion manifestations; the water intake was littered with garbage. The issues of preventing landslide accidents have been considered in many works by domestic and foreign researchers. Among them, we will mention only a few: (Hadiatska, 2019, 2020, 2021), (Ivanik, 2023, 2025), (Kaliukh, 2023, 2024, 2025), etc.

1. During the visual inspection of the area, where the gazebo is arranged, and slopes around it, the following defects and damages are found: there are cracks having the opening width of up to 50 mm and formed due to the paving base uneven deformation around the gazebo and cracks with the opening width of up to 10 mm in the gazebo supports foundations; there are no trays for collecting and draining surface water around the gazebo; in front of the plateau, on which the gazebo is located, an intercepting tray is arranged, which does not drain water because is clogged with soil and debris; the water drainage from the intercepting tray is not organized, which is why the slope is washed away by the water flow; the inclined trees called “drunken forest” are spread everywhere on the slope around the gazebo and the angle of some trees inclination reaches 45 degrees; on the slope the soil surface areas eroded by atmospheric waters are widespread, which is a water erosion manifestation; near the area, where the gazebo is located, there are the stairs and a drainage tray along them with the destroyed bottom, through which trees and vegetation grow. The combination of the above-listed damages is caused by the unfavorable operating conditions, soil base uneven deformations and complex engineering and geological conditions (one of the gazebos is located on the slope edge).

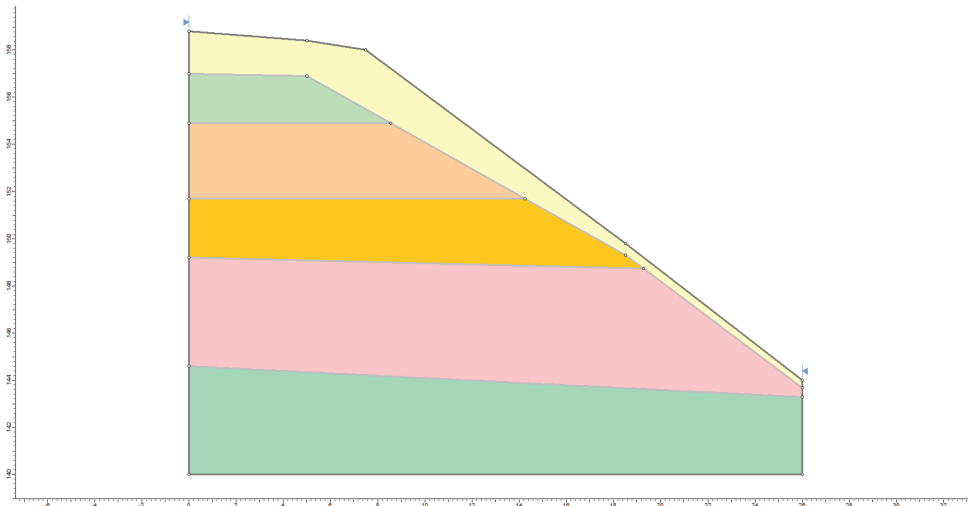
Figure 2 Design scheme (the engineering and geological section 8-8).

surveying results. The factor of safety was calculated with a software package using the Bishop (Cray), Yanbu, Morgenstern-Price and Spencer methods for assessing the stress-strain state of soil massifs under the static and dynamic loads action, as well as the stability coefficients of slopes and declivities. The slip surfaces had circular cylindrical shapes or were designated in the form of broken lines. The calculation was performed for 1 RM under the plane strain conditions. When modelling the soil massif, a soil model meeting the Mohr-Coulomb strength conditions was taken. The slope stability was calculated by the method of circular cylindrical surfaces with the Bishop (Cray), Yanbu, Spencer and Morgenstern-Price methods application. In Fig. 2 one of the design schemes for section 8-8 is shown.

Section	Factor of safety obtained by various calculation methods			
	Bishop	Yanbu	Spencer	Morgenstern-Price
In the natural state				
6-6	3,683	3,478	3,688	3,686
7-7	1,998	1,687	2,075	2,083
8-8	1,519	1,476	1,501	1,508
9-9	1,912	1,751	1,914	1,909
In the state of soils water-saturation				
6-6	2,078	2,043	2,081	2,085
7-7	1,130	1,081	1,128	1,130
8-8	0,937	0,917	0,936	0,933
9-9	1,114	1,020	1,109	1,109

2. The calculations results show that for all sections the slope normative stability is ensured with the design characteristics of the soils in a natural state. The slope along section 6-6 is in a stable state with the characteristics of the soils taking into account their water saturation. The stability coefficients of the slope soils along sections 7-7 and 9-9 are in a limit equilibrium state. Along section 8-8, the slope stability loss is possible in some areas with the characteristics of the soils in a water-saturated state.
