Landslide25_29**Integrated geotechnical monitoring on St. Andrew's Hill**

N. Molochkova (National Conservation Area "St. Sophia of Kyiv"), **L. Nishchuk** (National Conservation Area "St. Sophia of Kyiv"), **V. Saprykin*** (State Institution "Radioenvironmental Centre of National Academy of Sciences of Ukraine")

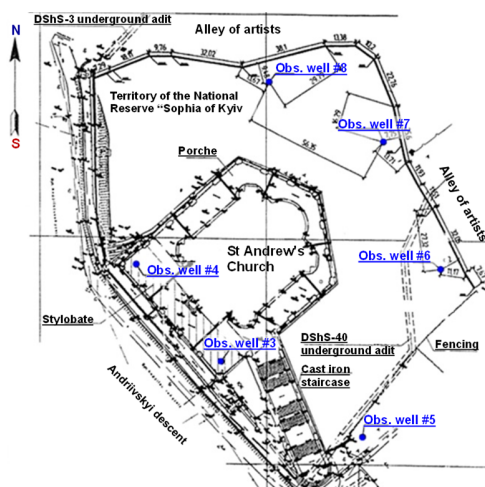
Figure 1 Layout of hydrogeological observation wells for monitoring ground-water levels on the territory of the St. Andrew's Church Museum

Archival data record the groundwater level in the 18th century at 165–168 m. From 1995 to 2009, it dropped to 156–163 m due to the action of adits (Figure 1, 2). In 2009–2011, the period of repair and restoration work, the level rose by 3–4 m (Saprykin et al., 2023), which is associated with several factors:

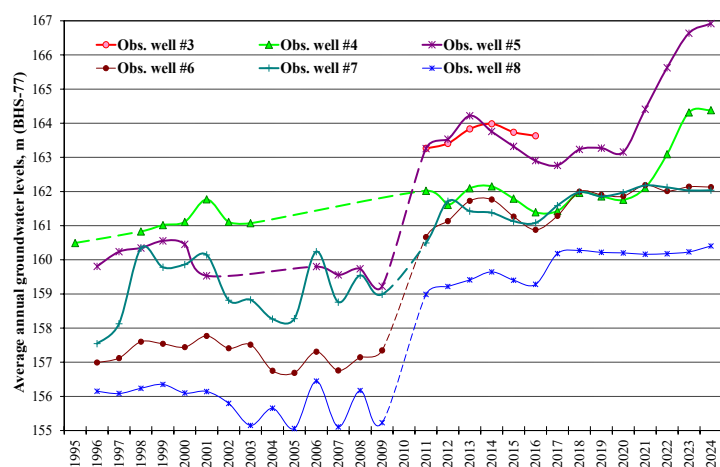
Figure 2 Average annual groundwater level regime on the territory of St. Andrew's Church from 1995 to 2024.

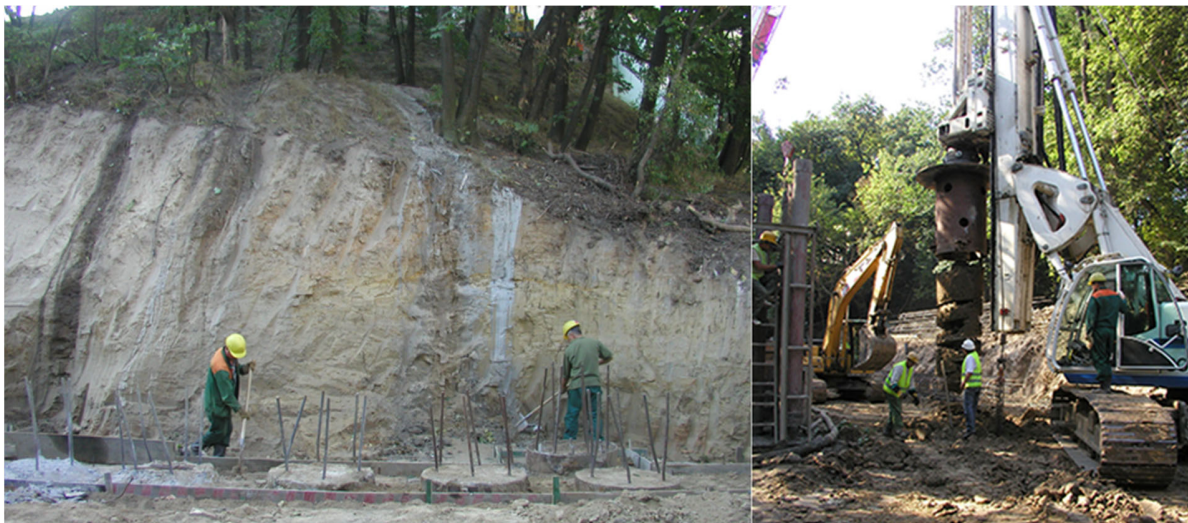
A retaining wall built along the lower boundary of the hill from bored piles up to 18-20 m deep with a strip grillage created an additional obstacle to the movement of water (Figure 3). According to calculations, the rise in the groundwater level should not have exceeded 0.4 m. However, in fact, it was 3-4 m. We believe that this is the most likely reason for the rise of the groundwater level at St. Andrew's Church territory, which requires further study.

Figure 3 Strengthening the stability of the hill of St. Andrew's Church with the help of bored piles

3. The groundwater regime on the hill of St. Andrew's Church is unstable. Its significant change (rise by 3-4 m) occurred mainly due to the barage effect created by bored piles along the perimeter of the hill during the first stage of repair and restoration works. The existing groundwater regime is influenced by natural and man-made factors.
