GeoTerrace-2026-064

## Geodetic Monitoring of Vertical Deformations in the City Cardiology Hospital Building in the Town of Bryukhovychi During Reconstruction

**\*I. Savchyn, Ye. Poberezhnyi, I. Brusak** (*Lviv Polytechnic National University*)

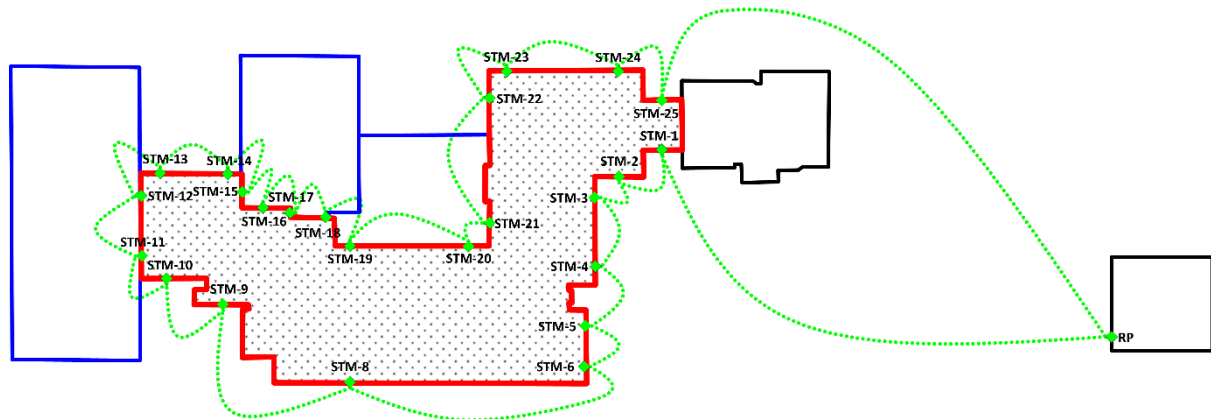
The monitoring network at the municipal cardiology hospital in the town of Bryukhovychi consisted of 25 wall deformation marks (STM1–STM25), evenly spaced around the building's perimeter, and nine biaxial mechanical crack gauges (C1–C9) to monitor crack opening in the horizontal and vertical directions (Figure 1.), which were installed on various floors in the western part of the building at existing settlement cracks. Wall deformation marks were installed as temporary monitoring points on the building's facade, while the crack gauges were installed inside the building at locations with documented characteristic settlement cracks.

**Figure 1.** Location of wall marks at the study object (red: monitoring building; black: existing buildings; blue: new buildings; green: Class II leveling survey)

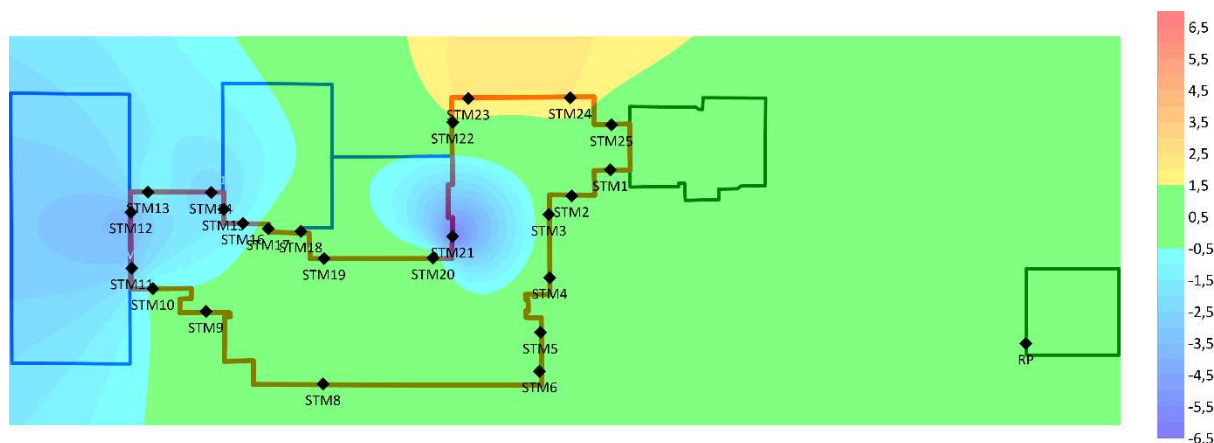
The results of six cycles of geometric leveling made it possible to identify three distinct zones of building deformation (Figure 2.), which reflect the different responses of the structures to the renovation and construction of new additions.

**Figure 2.** *Spatial Distribution of Deformations*

The stable zone encompasses the eastern and southern parts of the structure (marks STM1–STM10), where, throughout the entire observation period, the total vertical displacements did not exceed  $\pm 1.0$  mm, which is within the measurement accuracy and indicates the absence of significant settlement.

The first zone of localized settlement formed in the western part of the building, which directly borders the excavation pits and foundations of the new wings. Here, settlements of  $-1.0$  to  $-3.8$  mm were recorded for sections STM11–STM15; specifically, for STM12 and STM14, they were  $-3.8$  mm and  $-2.6$  mm, respectively. Another zone of localized settlement was identified in section STM21, where the maximum accumulated settlement was  $-6.1$  mm. A zone of local uplift was also identified in the northern part of the structure (sections STM23–STM24), where vertical displacements were positive and ranged from  $+1.5$  to  $+2.5$  mm. This pattern of changes may be associated with a local redistribution of stresses in the structure during reconstruction. Overall, the spatial distribution of deformations confirms that the recorded displacements are predominantly local in nature and are concentrated in the area of active construction work.
