Mon-21-057 Changing the dynamics of relief development within the Kaniv natural park under the influence of anthropogenic factors

A. Mienasova (Taras Shevchenko National University of Kyiv), *M. Krochak (Taras Shevchenko National University of Kyiv)

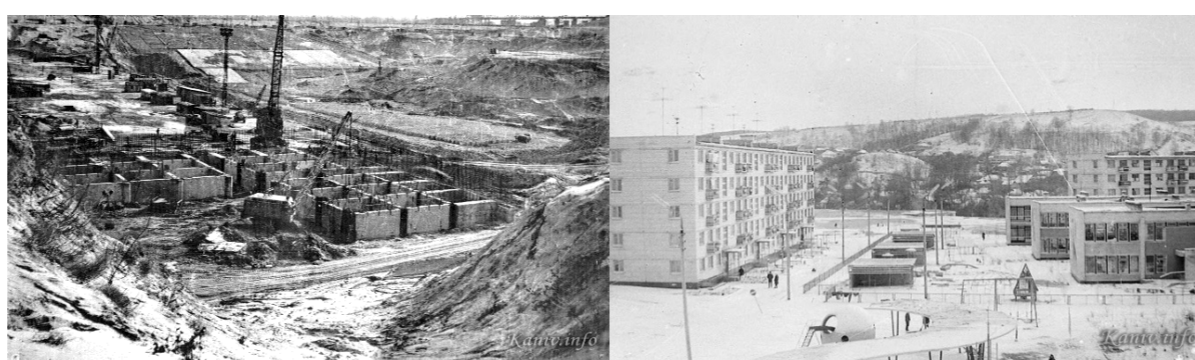
Figure 2 Anthropogenic activity: a – construction of the Kaniv HPS; b – new residential district on the artificial terrace.

During the preparatory stage of Kaniv HPS construction (in the period from 1967 to 1969) along the right bank of the Dnieper from the center of Kaniv to the hotel "Tarasova hora" there was reclaimed sandy terrace, almost 4 km long and 100 to 500m wide. As a result, the floodplain level was raised by 3-4 m and thus the basis of ravine erosion increased. The new houses, a highway, a pier, etc. were built on this artificial terrace (Figure 2).

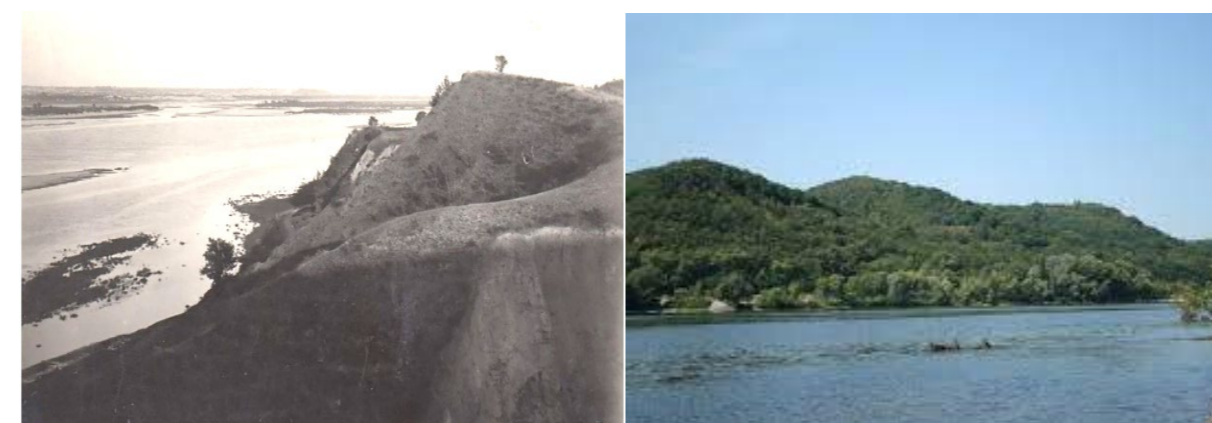
Figure 3 «Kaniv mountains»; a - ear of XX century, b – our days.

Due to the attenuation of erosion processes, bare hills are overgrown with hornbeam and mixed forests, in the thickets of which ravines are hidden (Figure 3). They have also changed their morphology. Part of the ravines turned into gulleets. Other ravines, where there is a significant difference in altitude, continue to develop and deepen, but their regime has also changed.

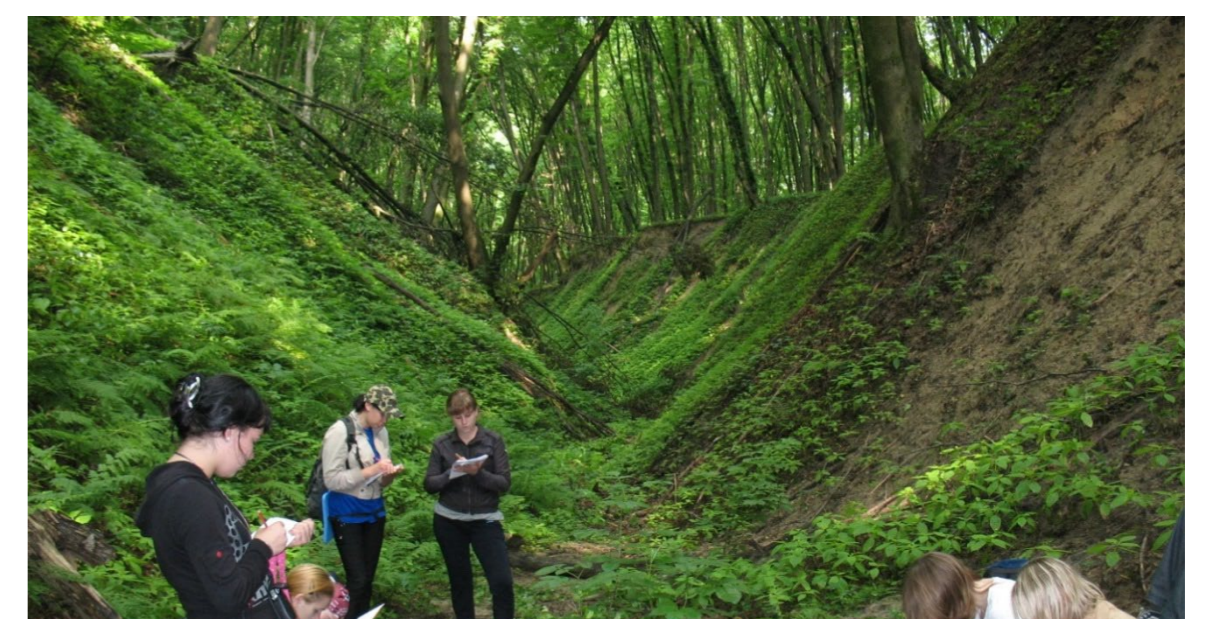
Figure 4 Upper part of the Melanchin Potik, our days

We observed the dynamics of changes in the ravines: Melanchin Potik, Kholodnyi, Marin, Pekarsky and Biliashivskoho. They begin with the highest, Marina hora, which has been finally covered with forest for today. Over the years of observations in the ravines there have been noticeable changes. For example, Melanchin Potik significantly changed its morphology. Gradually, the slopes of the modern riverbed began to overgrow (Figure 4). Periodic fall of trees led to the clogging of the thalweg,

the creation of natural dams, the retention of precipitation, the formation of temporary reservoirs at the bottom of the ravine. This, in turn, caused landslides of large areas of slopes, which over time were also covered with vegetation. In other areas, the water washed away the slopes, they collapsed, forming a water-mud mixture, which after drying covered a thick layer of the ravine's bottom, increasing the width of the thalweg to several meters. In the lower part of the ravine has been a complete cessation of deep erosion. There is a constant stream. It meanders, approaching one side or the other, washing the shores, carrying and depositing loose material at the bottom of the ravine. In recent years, the bottom of the mouth has expanded significantly, reaching 15-20m in some areas. The slopes here are completely overgrown.
