Landslide25_09**Assessing the Impacts of Landslides on Hydrological Structure and Vegetation in the Swiss Municipality of Blatten**

T. Malik, B. Tsibenko, I. Honchar, D. Liashenko, V. Kravchenia, O. Tsvyk (*Institute of Geology Taras Shevchenko National University of Kyiv*)

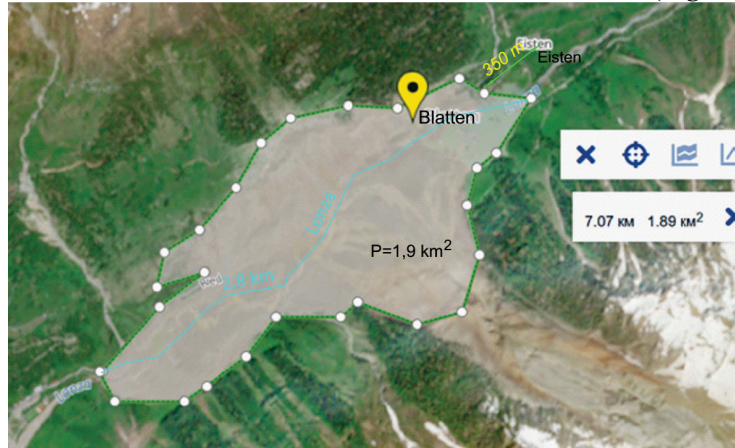
An assessment of the landslide’s impact on vegetation was carried out. According to the Sentinel-2 satellite image dated May 30, 2025, in the Copernicus Browser (*The Copernicus Data Space Ecosystem Browser, n.d.*) The area affected by the landslide in the village of Blatten and the surrounding territory was determined to be about 2 km². The landslide stopped approximately 350 meters from the village of Eisten, and about 2.8 linear kilometers of the Lonza River were buried under debris (*Figure 1*).

Figure 1 Measurement in the Copernicus Browser application (*The Copernicus Data Space Ecosystem Browser, n.d.*) based on the Sentinel-2 satellite image dated May 30, 2025.

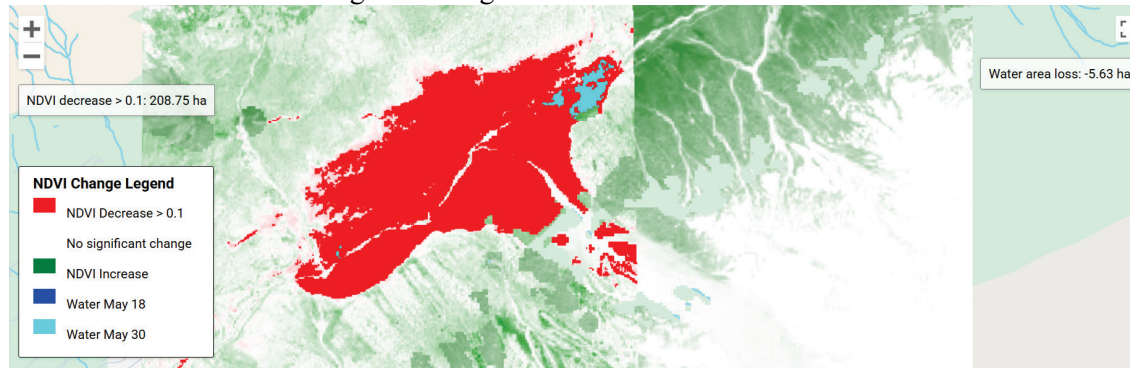
To assess vegetation degradation, the authors performed an analysis and comparison of two Sentinel-2 images: before the landslide on May 18, 2025, and after the landslide on May 30, 2025. Vegetation degradation was assessed through monitoring the NDVI index, which was calculated for the dates before (May 18, 2025) and after (May 30, 2025) the landslide using formula (1). The satellite image from May 30, 2025, shows complete soil degradation (*Figure 2*). The created mask indicating an NDVI decrease greater than 0.1 serves as a measure of vegetation degradation.

Figure 2 Assessment of vegetation degradation.

The obtained satellite indices make it possible to quantitatively and visually capture the impact of the landslide on the ecosystem within the village of Blatten. The authors established that significant degradation of vegetation cover occurred over large areas of Blatten and the surrounding territory. On the day of the landslide, a complete destruction of the Lonza River channel within the village was observed – specifically, a total disappearance of the water surface along the riverbed. The loss of water surface area was calculated by the authors of this study as the difference between observations on May 18 and May 30, 2025.

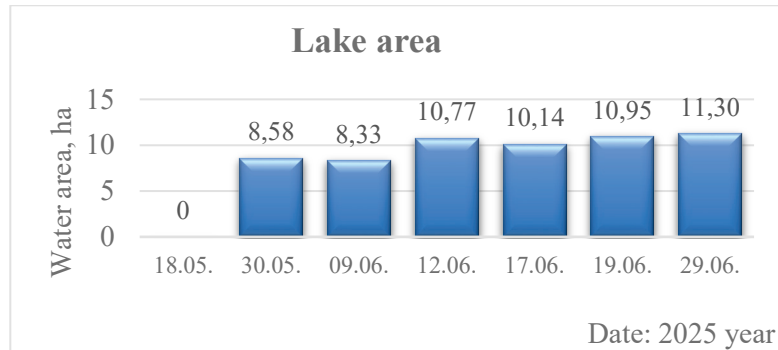
Figure 4. Dynamics of the water surface area of the uncontrolled lake.

Table 1 and Figure 4 show the dynamics of the water surface area of the uncontrolled lake for the period from May 18 to June 29, 2025.

Date: 2025 year	Lake area, ha
18.05.	0
30.05.	8,58
09.06.	8,33
12.06.	10,77
17.06.	10,14
19.06.	10,95
29.06.	11,30

In the following days after the landslide, a sharp rise in the water level, the formation of an uncontrolled lake, and the flooding of the territory were observed. The authors conducted an assessment and monitoring of changes in the area of this uncontrolled lake over a period of one and a half months after the landslide. The maximum area of continuous open water of the uncontrolled lake was observed on June 12, 2025, amounting to approximately 10.8 hectares. After June 12, 2025, a slow reformation of the river channel was observed. A dam breach could lead to flooding of settlements downstream.
