**GeoTerrace-2026-048****Comprehensive 3D Documentation and Modeling of a Ruined Wooden Church in the Village of Vyazivka for Cultural Heritage Preservation**

**I. Savchyn, \*N. Danyliv, M. Biliavskiy** (*Lviv Polytechnic National University*)

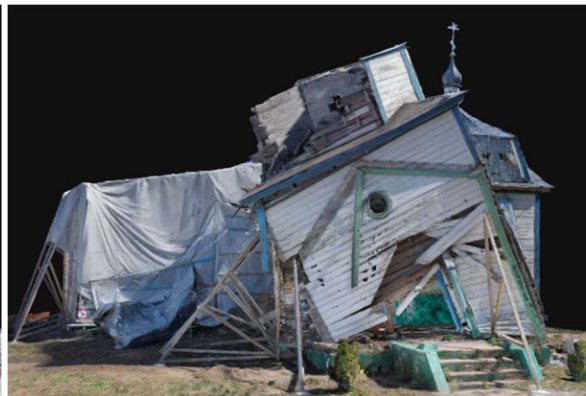
*Figure 2. Textured 3D model*

Terrestrial and aerial photographs were processed in RealityCapture. Based on these data, a photogrammetric model and point cloud were generated, followed by alignment with the laser scanning data using GCPs. The accuracy of the mutual alignment of the obtained datasets was within 5 mm. Additionally, a high-resolution mesh model Figure 1 was generated from the photogrammetric data and textured Figure 2. The resulting photorealistic model provides a detailed visual representation of the preserved wooden structures, collapsed beams, and remnants of the dome. Orthophoto plans were also created for individual facades, providing metrically accurate representations of their surfaces.

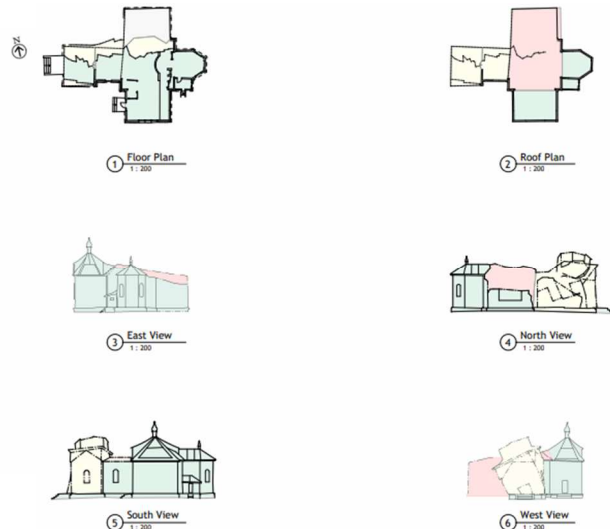
**Figure 4.** Facade plans

Based on the integrated point cloud and photogrammetric data, a 3D model of the ruined church was created in Autodesk Revit, and a set of graphical materials was prepared to document its current condition. A site plan was generated at a scale of 1:200, showing the recorded locations of fallen and displaced structural fragments Figure 3. A building plan was created at a scale of 1:50, indicating the fallen debris, the four facades (north, east, south, and west), and two cross-sections—a longitudinal section and a transverse section through the transept. In addition, orthophoto plans of the four facades were created based on the integrated laser scanning and photogrammetric data Figure 4.
