Landslide25_14

Landslide mitigation measures along the banks of Carpathian rivers

SUMMARY

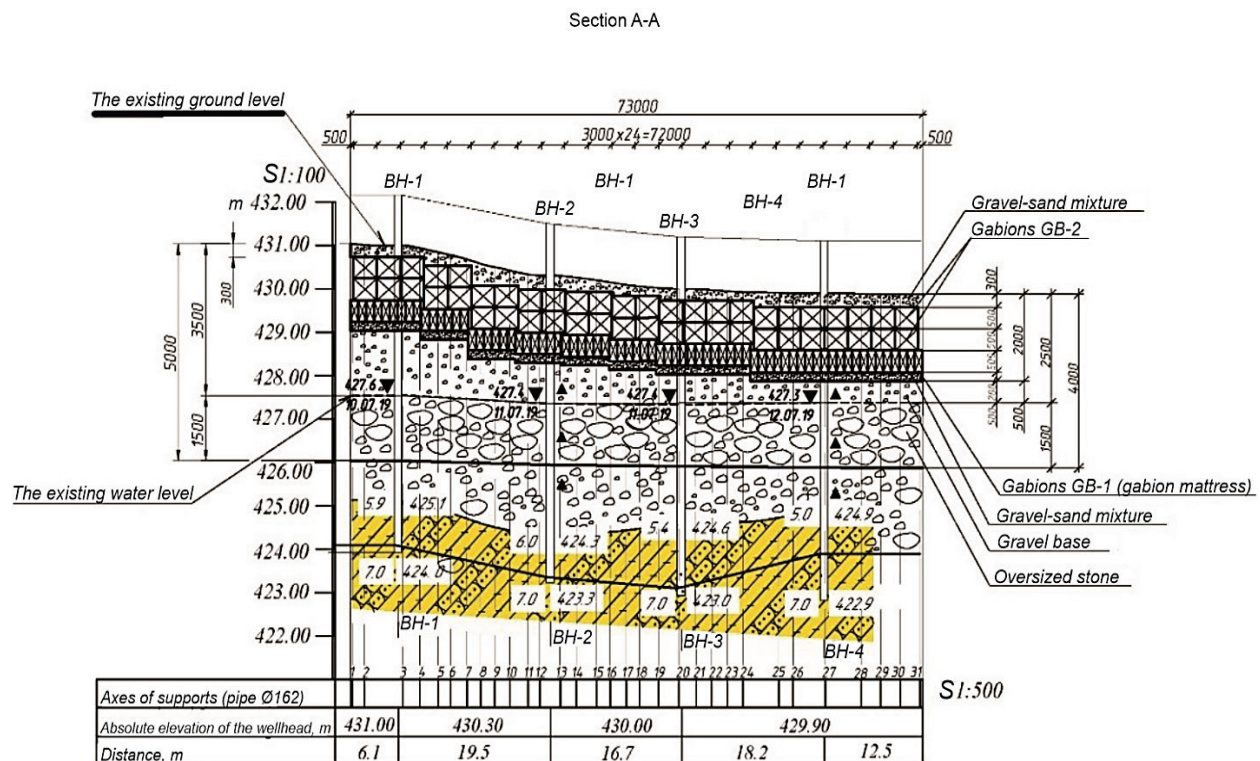
Figure 1 Scour Depth Calculation Scheme for the Bystrytsia Nadvirnianska Riverbed (BH 1-4 – Mining well number (borehole))

where, $d_c = 0,086 \text{ m}$ the average diameter of soil particles (gravel with boulder content, EGE No. 2) (Fig. 1) subject to erosion at the riverbed; V_m - maximum flow velocity; V_{np} - allowable (non-scour) flow velocity.

It should also be assumed that certain sections of the riverbed may be composed of either coarser or finer clastic material. Accordingly, the average particle diameter will vary, leading to fluctuations in the estimated scour depth within the range of: $2.30 \pm 0.50 \text{ m}$. (DSTU ISO 15175, 2005), (State Committee of Ukraine for Urban Planning and Architecture, 1997).

At a near-bed flow velocity of $V_m = 4,75 \text{ m/s}$, partial erosion of certain sections of the bedrock surface composed of weathered argillites is possible. In the study area, the bedrock layers are represented by alternating argillites and sandstones; the sandstones are considered non-erodible.
